CRUISE REPORT NO. 90
OF PE/CK.4

BASELINE STUDY FOR COASTAL MANAGEMENT
REEF, BEACH, AND LAGOON NEAR RAROTONGAN HOTEL
RAROTONGA, COOK ISLANDS

CRUISE CK-84-1

21 MAY TO 12 JUNE 1984

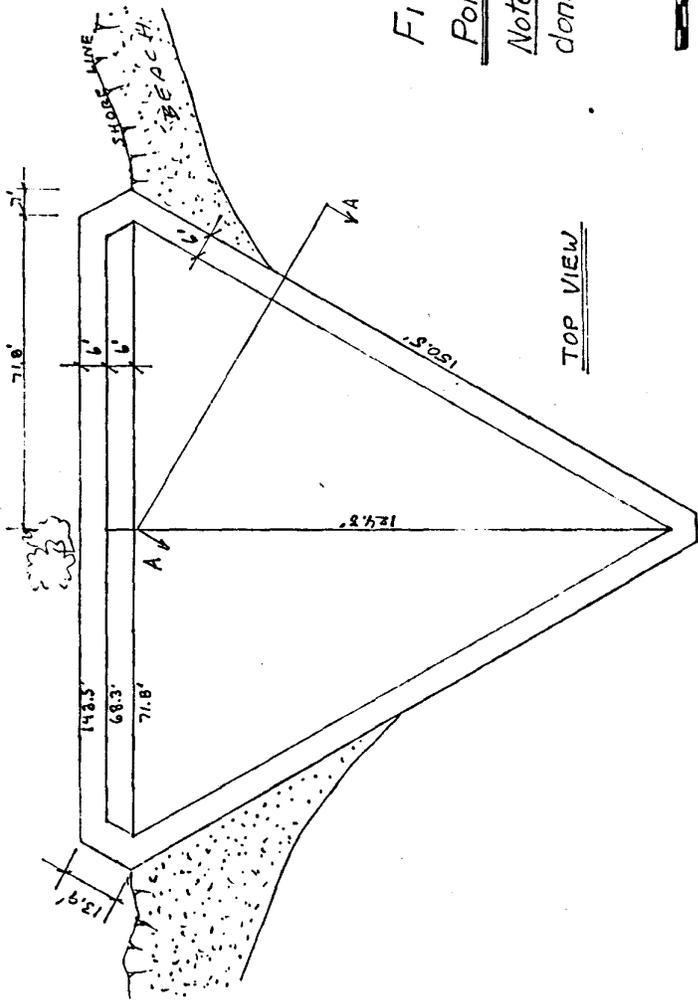
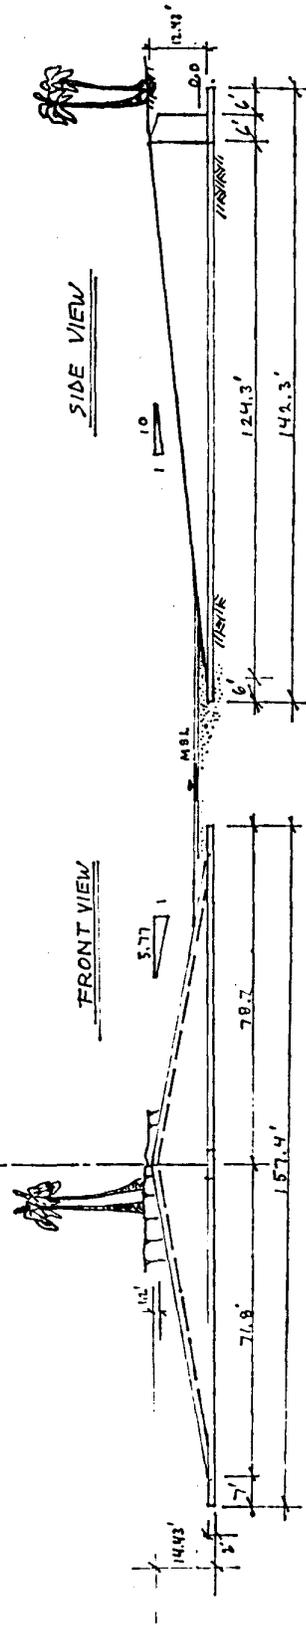
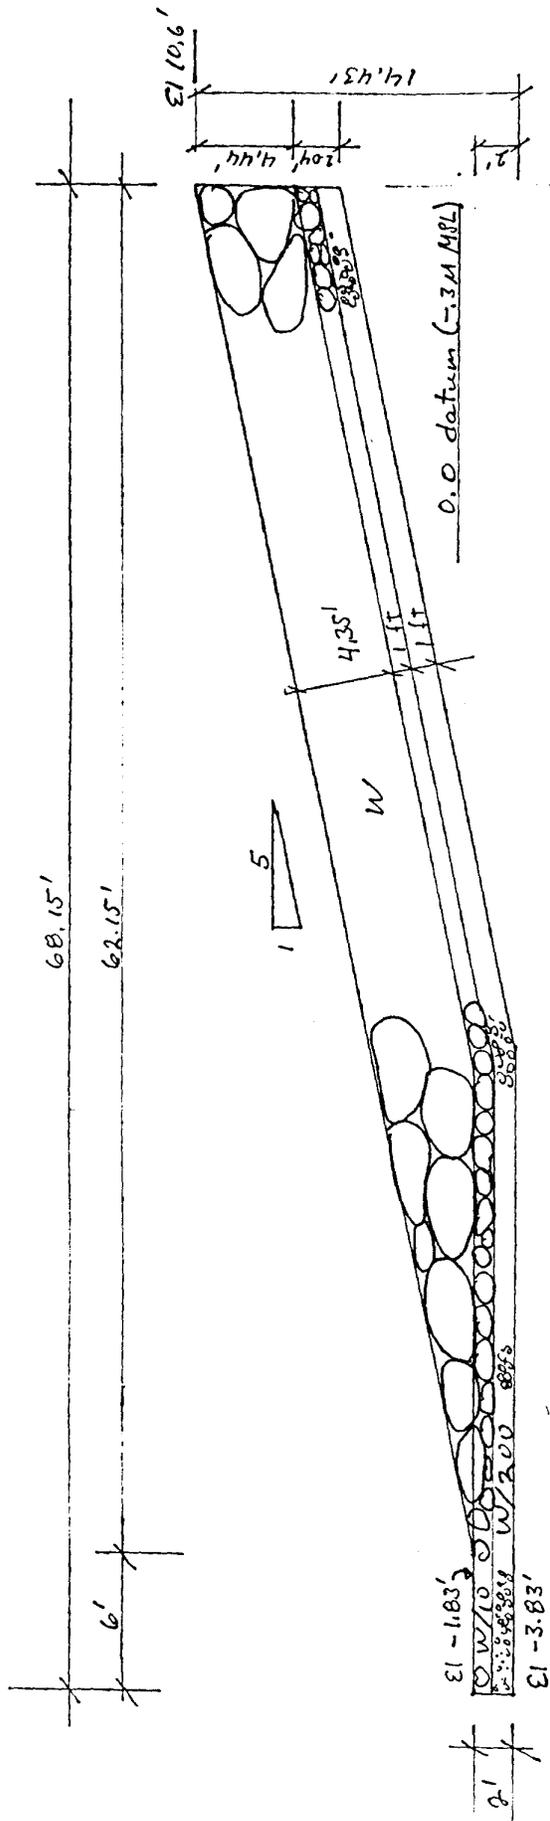
FIGURE 6
Point Structure
Note: No foundation work
done.

Section AA
Point Structure

Rock	(kg)	(lbs)	Size (ft)
W/10	424	933	2.16
W/10	42	93	.98
W/200	2.3	5	.36

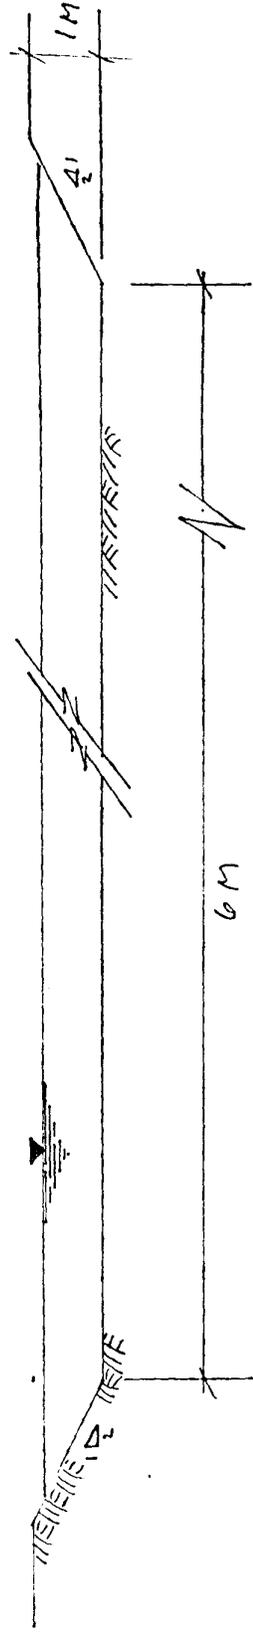
Figure 7

Section-CC
Storm Bar Channel

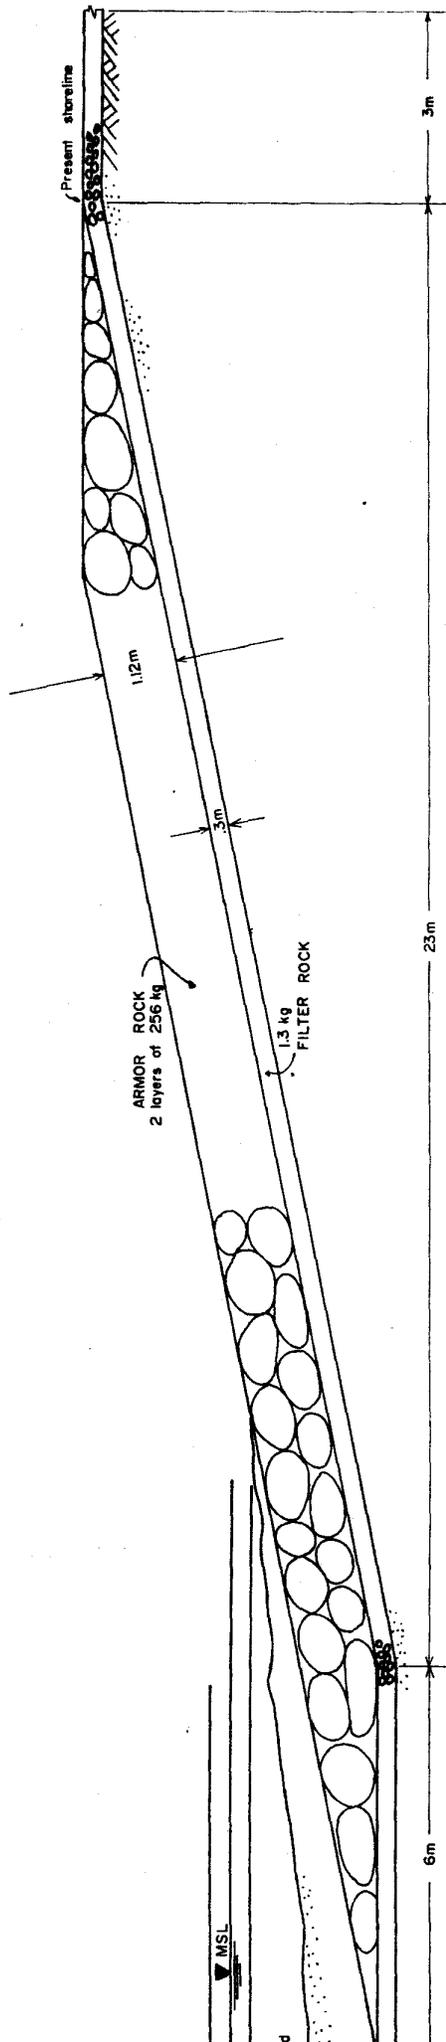
FIG. 4

Length of seawall - 160m

USE ANGULAR ROCK
s.g. = 2.21

PROPOSED RUBBLE MOUND SEAWALL FOR
BEACH SECTION IV RAROTONGAN HOTEL

A seawall could be located along section IV where the shoreline is receding. Such a structure would perform several functions. The more important is to minimize wave reflection and transform wave energy to heat. A second function is to reduce flooding on shore and provide a return route for overtopping water. Another function in this case is to prevent beach erosion due to the trade wind generated waves.

The Hudson formula for rubble structure was employed to select the armor stone weight, W .

stone, s is the specific gravity of stone related to sea water, and a is the angle of slope measured from horizontal. Using s of 2.21 a of 11.3 degrees, H of 1.53m the weight, W of the armor cm of filter and 4300 per cm of filter delivered, the material cost would be on the order of (NZ) \$83, 448.

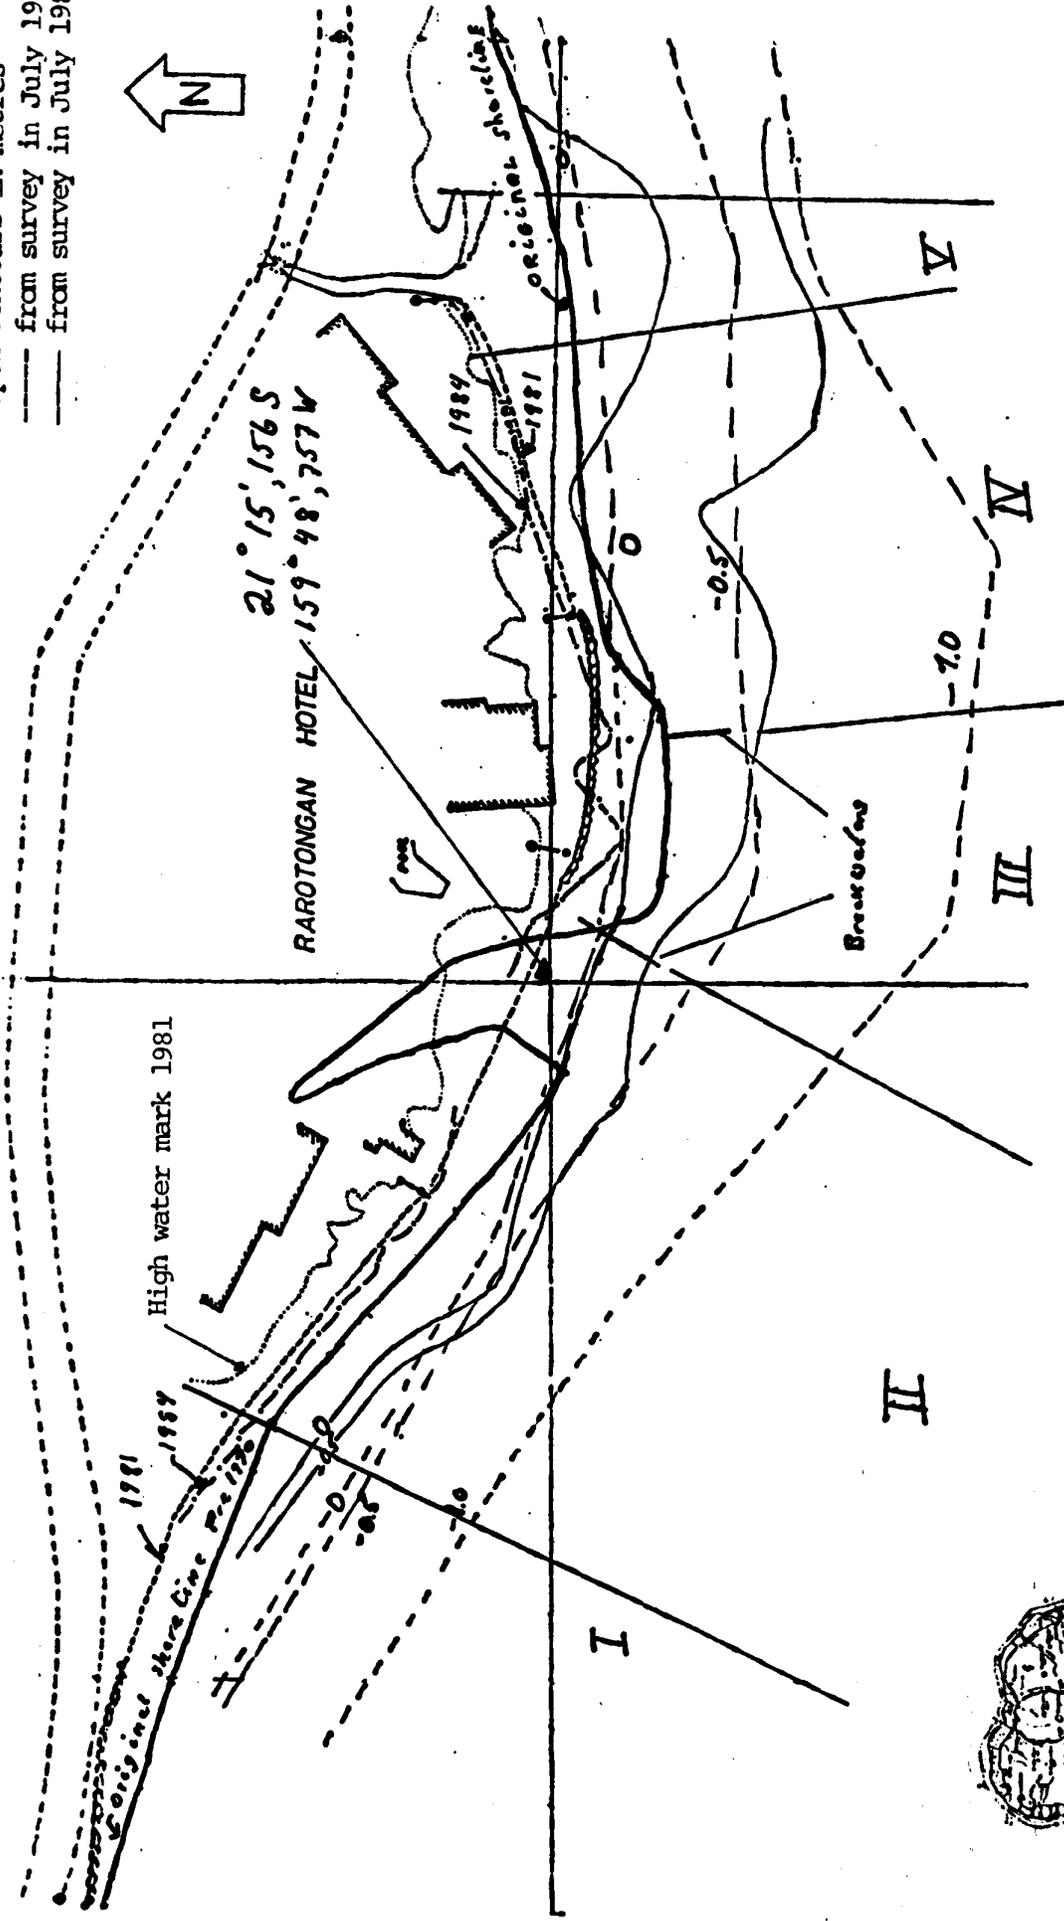
Fig. 1: Study Area

Section 1 lies to the west of the Rarotongan Hotel beach as shown in Figure 1. It has during the past three years lost sand at an estimated rate of 255cm per year (cm = cubic meters). Some 73 percent may have transported westward by trade winds waves and the remainder appears to have been washed out onto the near shore by secondary reef waves where strong reef currents carried the sand eastward. There is no evidence of shoaling to the west.
