Turtles and their habitats on Mauke, Southern Cook Islands.

Phil Bradshaw B.Sc. M.Sc. and Nerissa Bradshaw

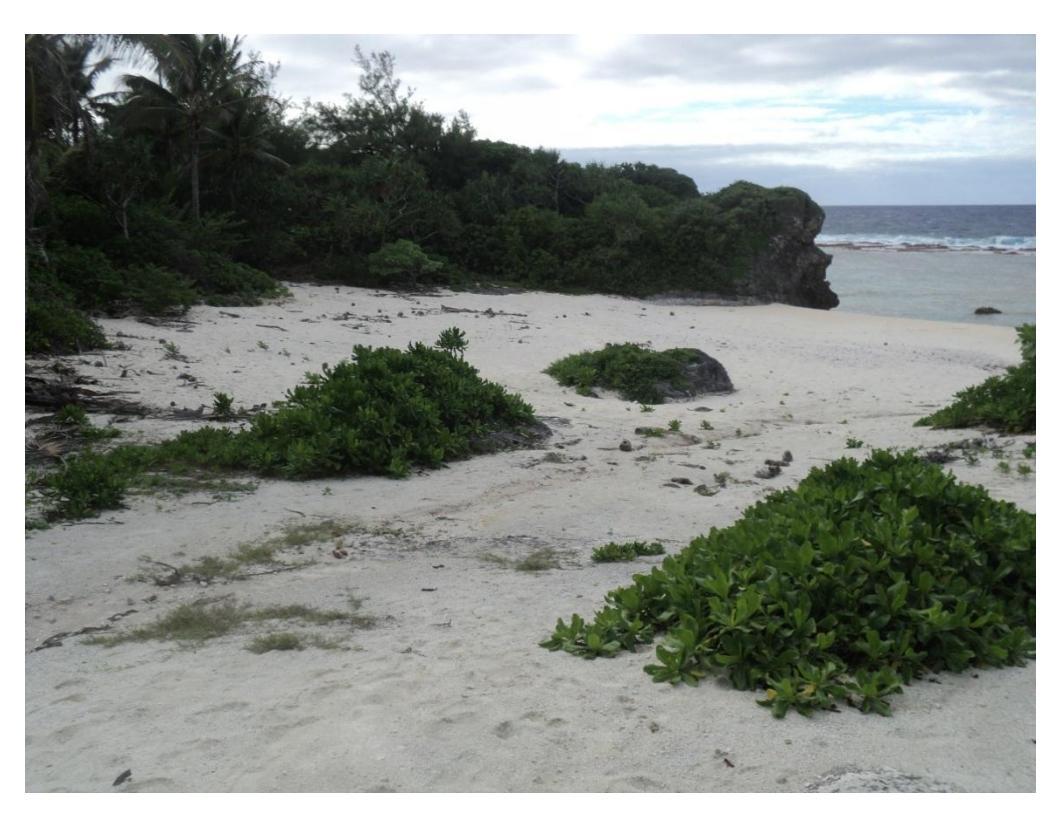
Anaraura (refer to Figure 5 in Appendices) hosted twelve activities in total (two of which were recorded as one activity) with three confirmed nests, three possible nests, three abandoned egg chambers and three body pits. There were mixed anecdotal reports about how many emergences occurred therefore all activities (except the one previously stated) were recorded separately. The beach was both deep and, for a wide section, backed by mixed forest allowing nesting in amongst the vegetation, which is a preference for green turtles. One of the nests and a body pit were laid in a small cove, west of the main beach. All nests were laid at least 30 metres from the water therefore inundation would be unlikely.

Figure 5 largest bay of Anaraura (two nests, three possible nests, three abandoned egg chambers and two body pits)

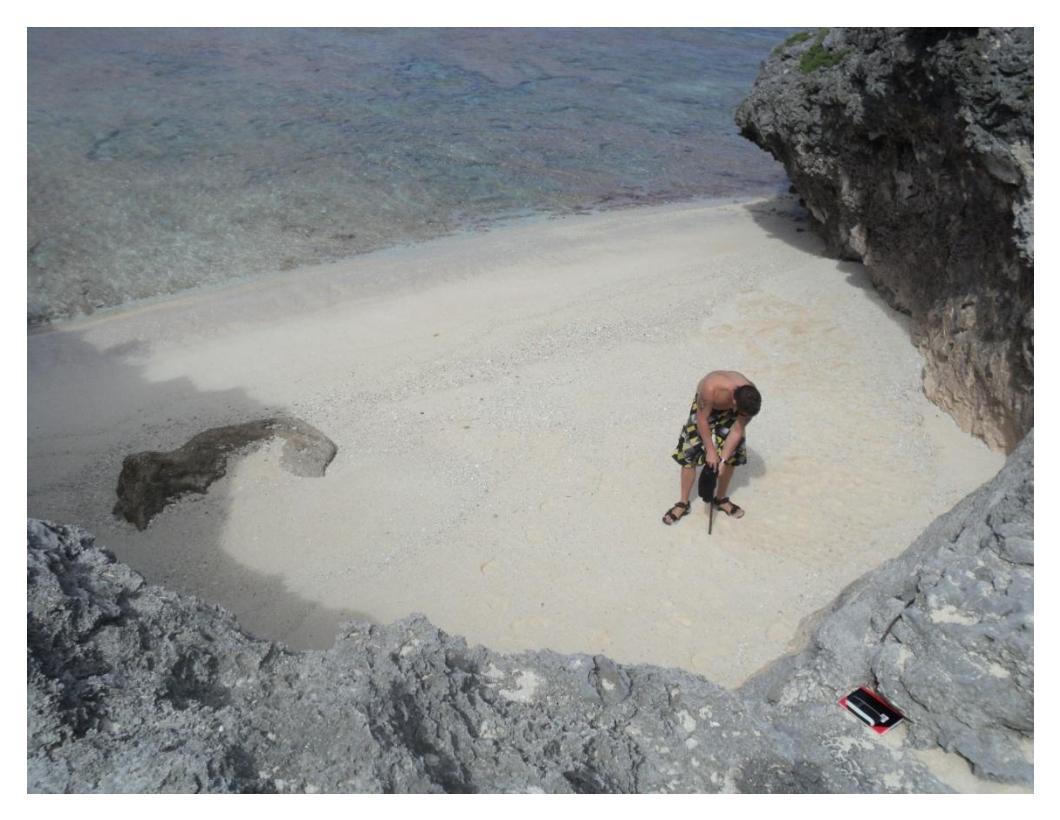
Anaiti consists of three separate bays which all had reports of nesting (Basilio Kaokao *pers.com*. 2012). The most southerly cove (refer to Figure 6 in Appendices) was shallow and surrounded by makatea with approximately 2 - 3 metres of suitable nesting habitat above the high water mark. This beach had three nests anecdotally; however no signs were observed or found despite extensive searching.

Figure 6 Anaiti Bay 1

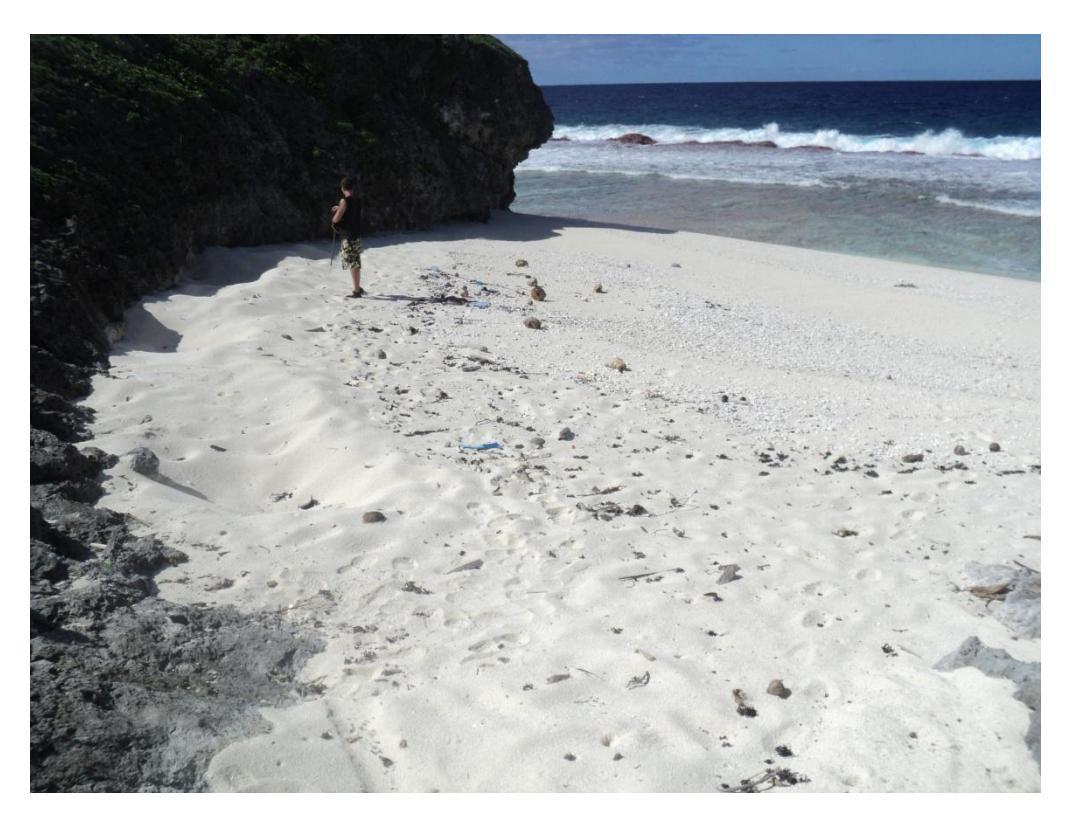
The second bay (Terua Okea, refer to Figure 7 in Appendices) had a large area of disturbed sand along the back of the beach, close up to the makatea, where a single emergence had resulted in two nesting attempts before successfully nesting. The sand here was coarse and whilst excavating the nest the sand would cave in easily. This was noted as a possible reason for the two failed attempts as the sand depth was adequate.

Figure 7 Anaiti Bay 2 (two attempts then a nest)

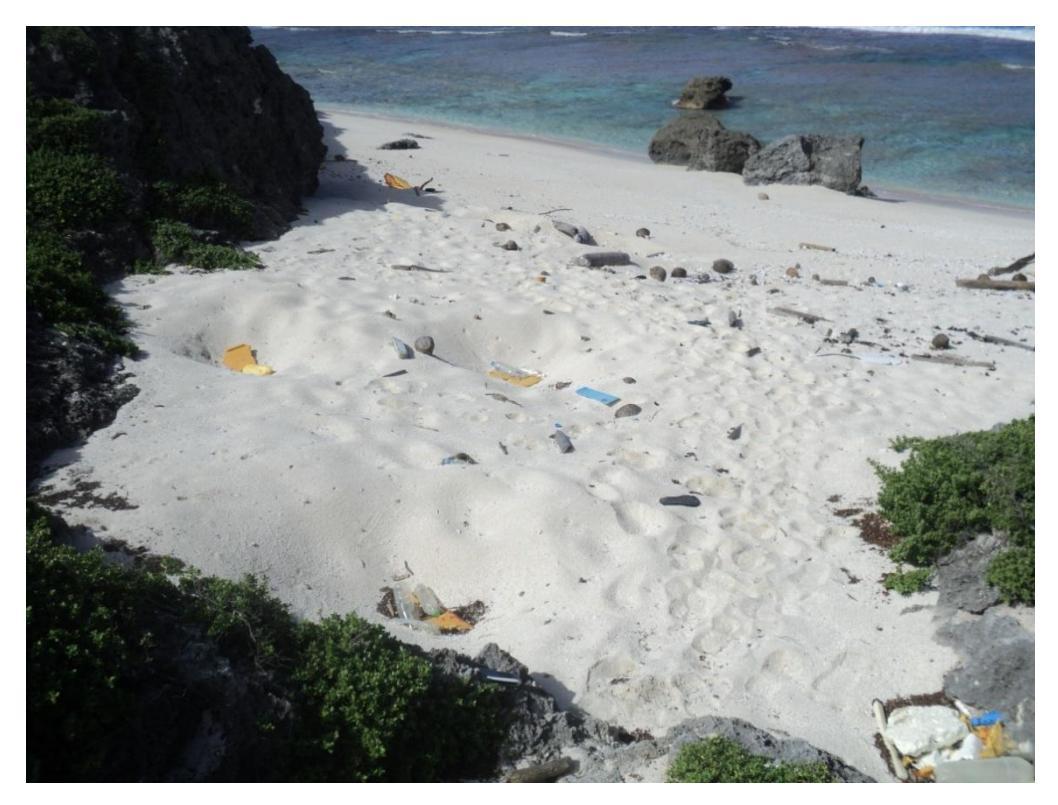
The most northerly cove of Anaiti (refer to Figure 8 in Appendices) had four separate activities, two of which were confirmed nests. Although both nests were recorded as confirmed, one nest only revealed four hatched shells and the egg chamber was not located. The nest was heavily disturbed with few features to aid in egg chamber location however the four hatched shells were fresh (from this

year) and the shells could not have been from the other nest due to the distance between their locations. It was thought that the nest may have been predated or poached and these four eggs were missed, although this is speculative. In general this cove had more suitable nesting habitat than the other two coves (of Anaiti).

Some of the beaches were polluted with plastics and also foam from a boat which has been wrecked on the reef (refer to Figure 8 in Appendices). In its present quantities neither the foam nor the plastics would cause problems to nesting turtles and it is regularly cleared by Basilio and his scout group. Through quick action from Basilio and other community members the diesel and other potential pollutants from the wreck were removed, however the boat should be removed before it causes any further pollution or damage to the reef.

Figure 8 Anaiti Bay 3 (two confirmed nests and two abandoned egg chambers)
